AG-AVT-140

Corrosion Fatigue and Environmentally Assisted Cracking in Aging Military Vehicles

Published March 2011

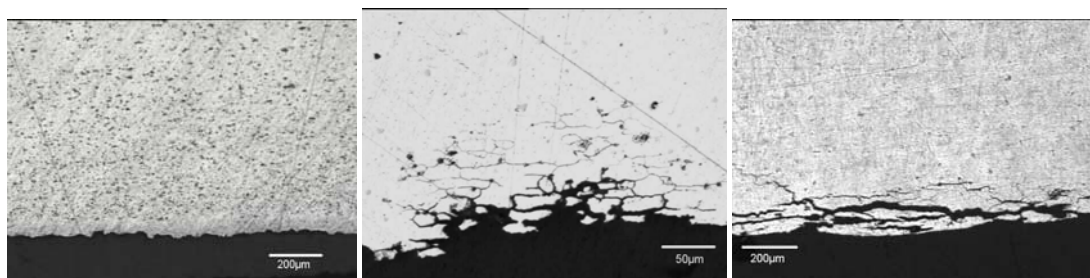
Figure 4-1: Optical Micrographs Showing the Modified Discontinuity States from Naturally Corroded Components that were Progressively Polished.

(a) Images from naturally corroded 2024-T3 fuselage lap joints.

From this type of study, the growth of different types of damage can be estimated, which could then be used to more accurately predict the life of components that are susceptible to corrosion. For example, a damage characterization study was carried out on corroded lap joints in which sections were taken and progressively polished [1]. From the different images, corrosion pit sizes were measured taking into account the presence of intergranular attack. The results, shown in Figure 4-2, indicated that as the thickness loss increased the pit shape tended to become elongated (shallow but long). As can be seen from this figure, as the thickness loss increased, the pit shapes tended to take on a high aspect ratio, shallow but long. The exception to this trend was the pits that were present at the base of environmentally assisted cracks, which occurred in the presence of a sustained stress, EAC_{ss} , and have been referred to as pillowing cracks. Previous studies have shown that these cracks usually occurred in areas where the thickness loss was small and only a small pit was present at the faying surfaces. Since the material thinning was high in the area examined during this study, it is assumed that these large pits developed over time after the environmentally assisted crack had nucleated.

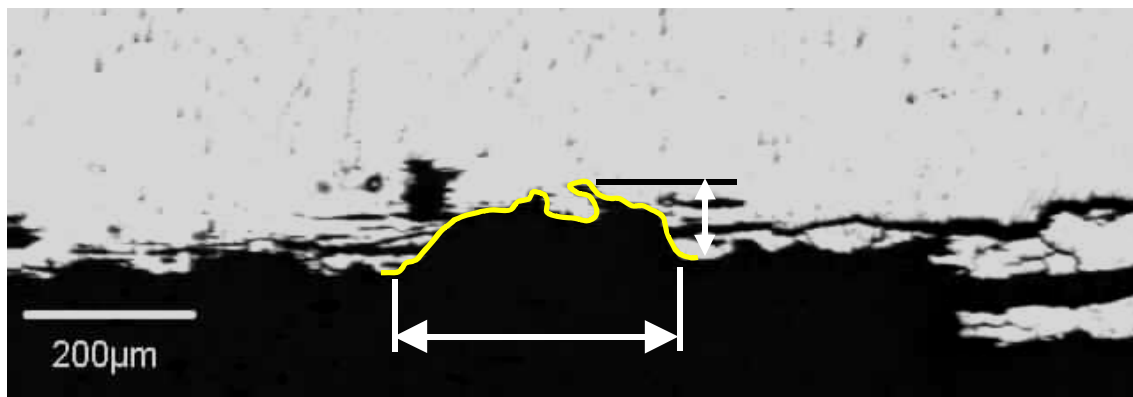
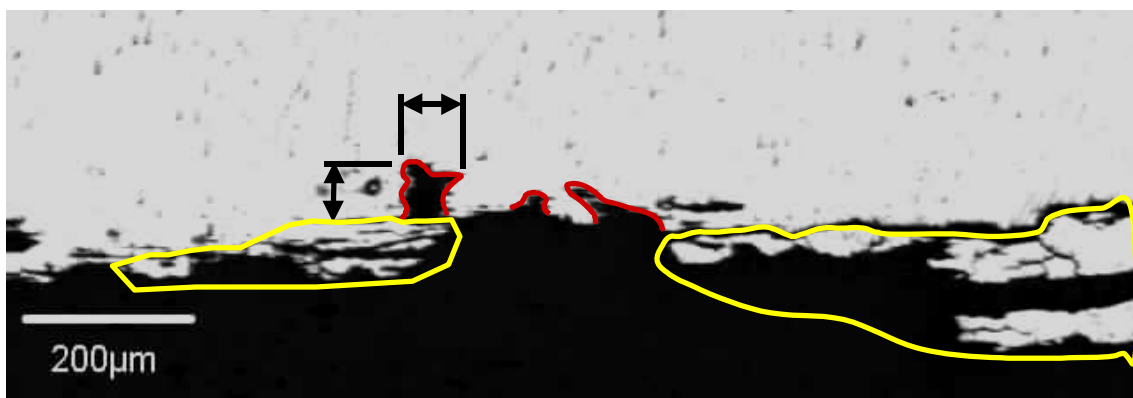
The other microscopic techniques, laser scanning confocal microscopy and scanning electron microscopy are capable of determining small changes in the surface topography. However one disadvantage to using these techniques is that the damage that is present must be on a direct line of sight in order to measure its size, which means intergranular cracking or corrosion cannot be detected. This type of cracking must be taken into account since the material affected by it is incapable of carrying any stress. Therefore this material would not have an influence on any pits in the immediate vicinity of the intergranular cracking and thus the stress concentration at the base of each pit would be lower than if the material surrounding the pit was undamaged. For example, as can be seen from Figure 4-3, if the intergranular crack is not taken into account the pit width and depth would be 346 μm (0.0136 inch) and 159 μm (0.00626 inch), respectively. However, the presence of the intergranular crack would increase the number of pits from one to three and the dimensions of the largest of these “new” pits would be 74 μm (0.00291 inch) wide and 64 μm (0.00252 inch) deep, which is a significant decrease. This decrease would tend to delay the onset of cracking by reducing the stress concentration at the base of the pit.

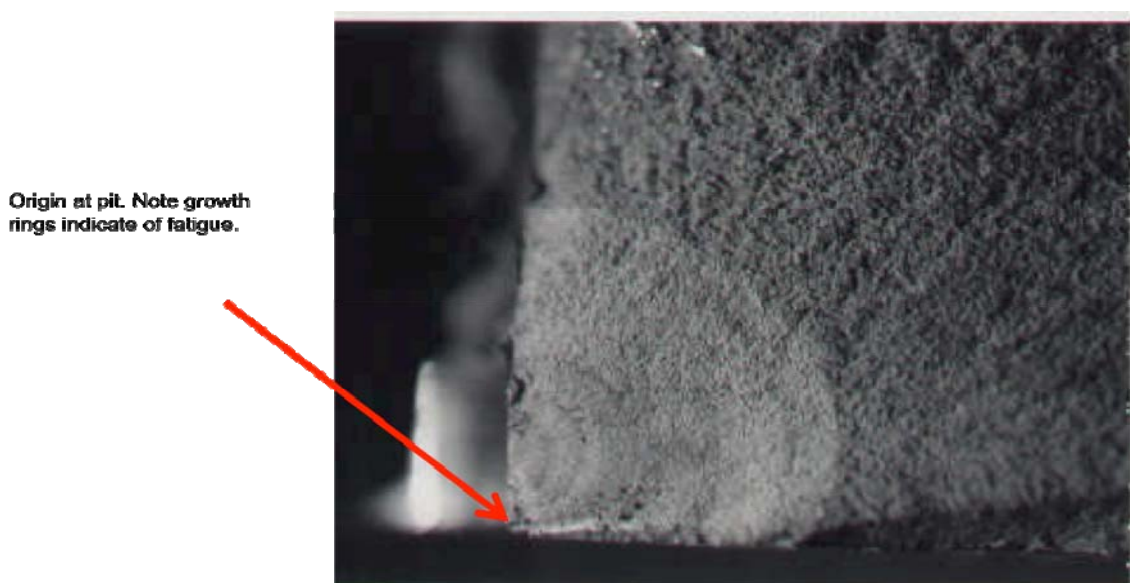
Figure 5-5: A Second View of the Fracture Surface of C130 "Porkchop" Fitting that Unexpectedly Failed from Pitting that Transitioned into Cracks.

The following is an example of unexpected pitting corrosion on a “non-critical component” detected in service. The C130 aircraft, used in many countries throughout the world, was found to have cracking in a fitting that is in the rear of the aircraft and is referred to as either the “Porkchop” fitting or the “hockey stick fitting”. Which reference is used is a function of the country in which the problem was discovered. Some indicated the problem was due to stress corrosion. This is not viewed likely since the component experiences cyclic loads. When both DND, Canada, and the New Zealand forces were experiencing cracking of the component they decided to have competent failure analysis labs evaluate the cracked fittings further. Thus, the Aerospace and Maritime Research Laboratory (AMRL) in Melbourne, Australia and the Quality Engineering Test Establishment (QETE) in Gatineau, Quebec, Canada performed failure analyses on the subject components. Additional failure analysis was done by the University of Utah Quality and Integrity Design Laboratory (QIDEC) and IAR (Institute of Aerospace Research) in Ottawa, Ontario, Canada. Figure 5-4 and Figure 5-5 show two views of the pits that nucleated the fatigue cracks. In addition, growth rings typical of fatigue, in this case most likely environmentally assisted fatigue crack propagation, are also clearly apparent. AMRL and QETE were both helpful in identifying the true failure mode in this case. The subject component had not been identified as a structurally significant item. The cracking was found initially by diligent maintenance personnel. Subsequent to the discovery of the corrosion pitting as the source of the cracks a program was put into place to monitor the area in question for corrosion thereby preventing the rampant formation of both corrosion pits and fatigue cracking. This was a significant aid to all the forces flying this particular transport aircraft.

(Photo by Ms. Amy Taylor, and David W. Hoepfner, University of Utah, 1999. In this view the crack nucleated at the lower left corner at a pit and propagated by corrosion fatigue. Note the growth rings as the crack propagates from the lower left toward the upper right corner of the photograph.)

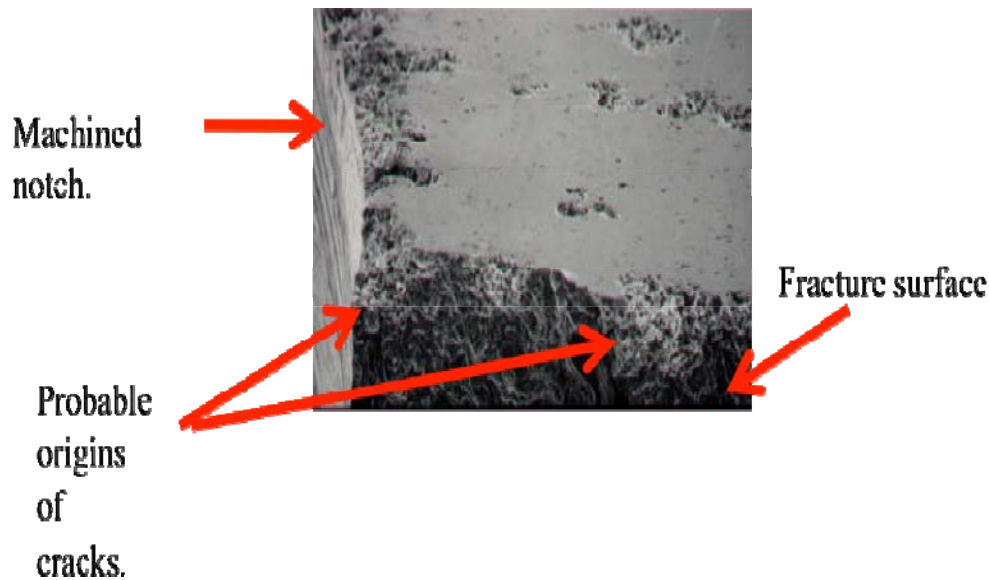
Figure 5-6: View Showing Corrosion Pits Nucleating Cracks.

Figure 5-6 and Figure 5-7 above show, respectively, the formation of fatigue cracks at corrosion pits and how fatigue cracks are observed to link pitting. It has been known for some time that both these occur. Thus, corrosion pitting often creates multiple site damage. The characterization studies done recently at the UU QIDEC laboratories have been instrumental in identifying features of pitting that are useful in modeling (see Chapter 7 and references [27]-[49]).

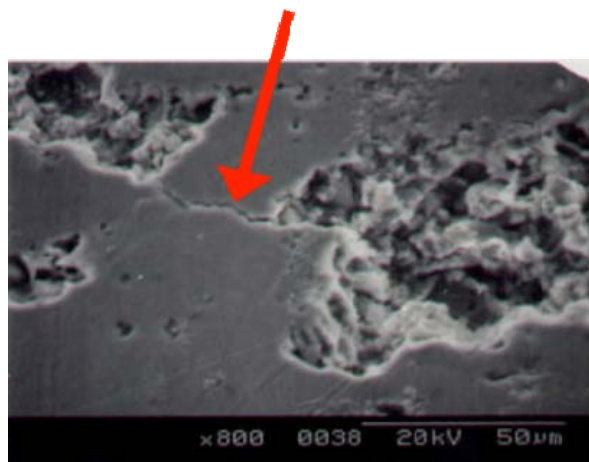
Figure 5-7: View Showing Other Pits with Fatigue Cracks Propagating Between Them.

Fatigue crack joining two pits. This is a common occurrence.

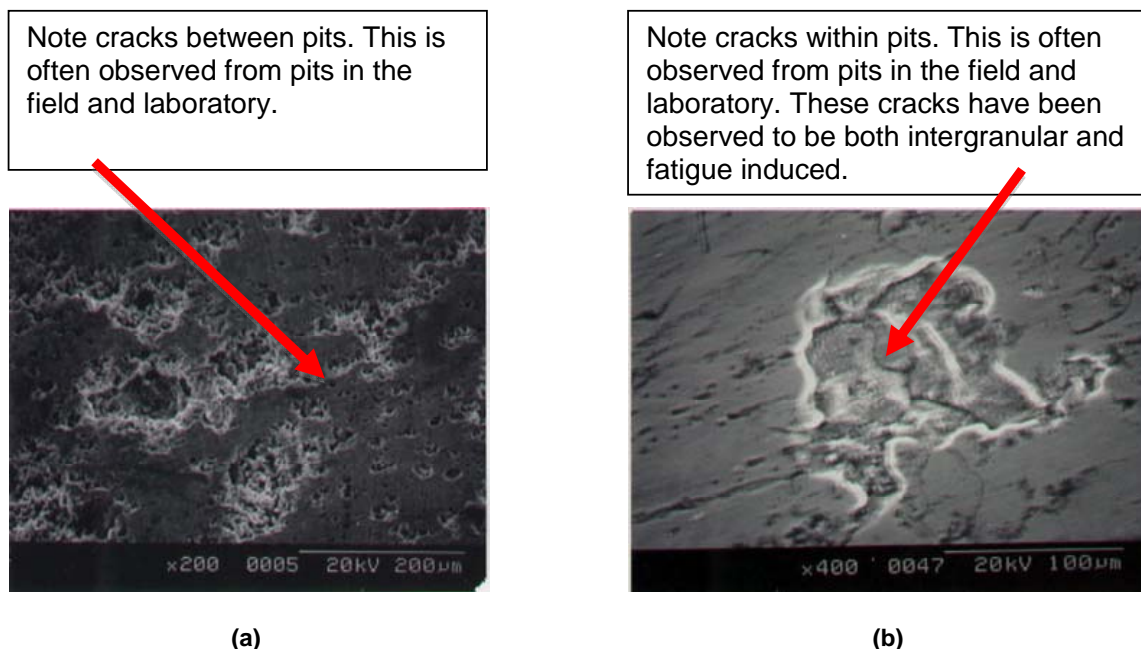
Figure 5-8(a) below shows the frequently observed occurrence of either sustained load or cyclic load induced cracks forming and linking pits. This has significant implications in formulating repair practices and in developing accurate models to predict corrosion pit growth rates and incorporating them into

models. On the other hand Figure 5-8(b) shows a view of cracks in the bottom of pits. This observation was made quite frequently. (Although not visible in this photo cracks also were observed in pit walls. This too was frequently observed).

Figure 5-8: Views in the Notch of Corrosion Fatigue Specimens Tested in the QIDEC Laboratory at the University of Utah (2000). Alloy was 7075-T6 tested in 3.5% salt water.

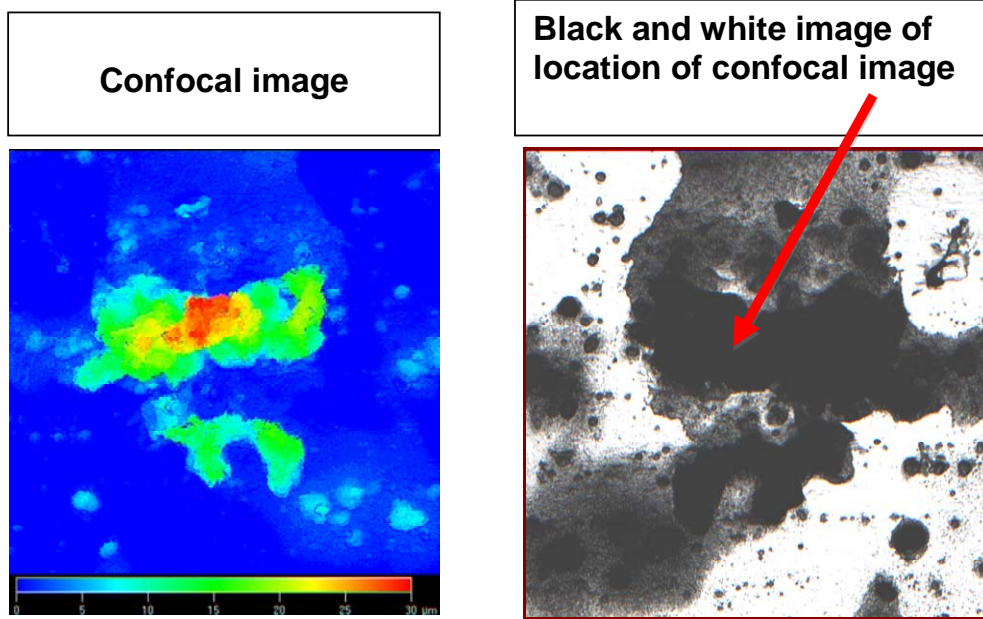
Figure 5-9: Post Corrosion Exposure of 30 Hours, $d \sim 0.0012$ " (30 mm) of Pit: Left image shows typical confocal image with variation in color showing depth – red indicates the deepest area of the pit; Image on right shows area where confocal image was taken.

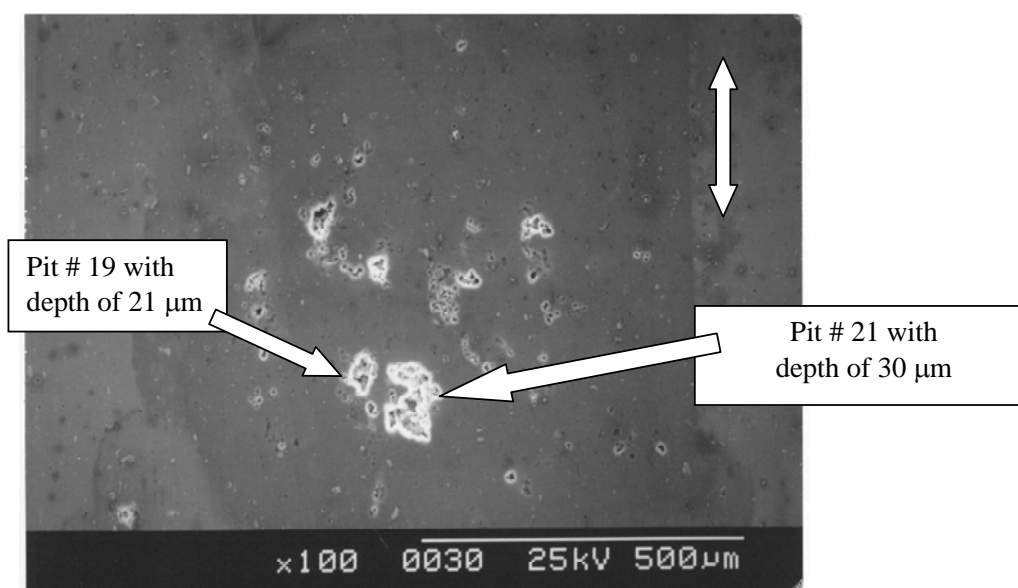
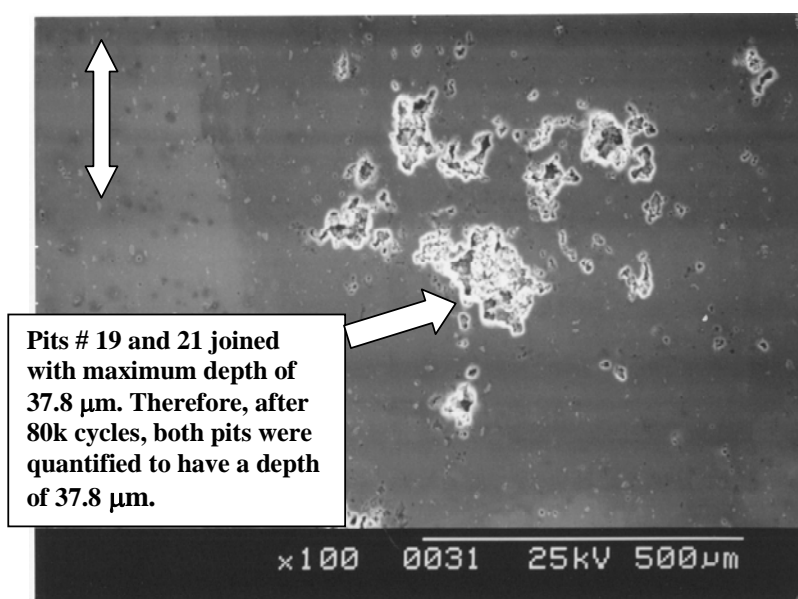
Figure 5-10: SEM Photos Showing Pits Developed Under Corrosion Fatigue Conditions:
(a) After 60,000 Cycles; and (b) After 80,000 Cycles. Vertical arrows indicate loading direction. Depth of pits determined by confocal microscopy.
 (Material was 7075-T6 tested in ASTM 3.5% NaCl solution).

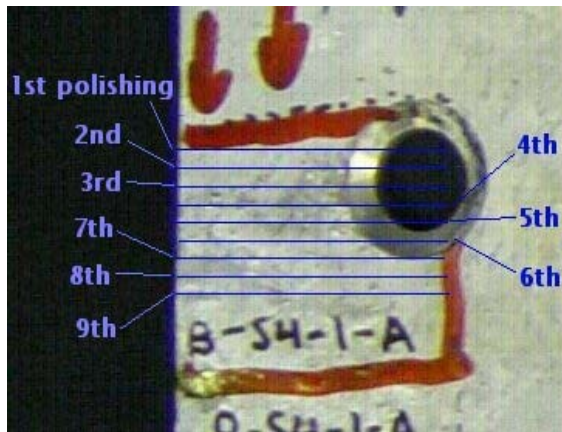
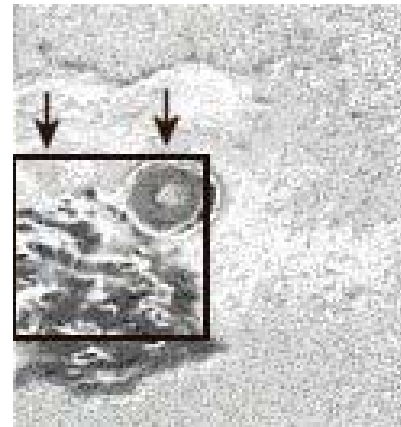
To document the damage caused by exfoliation corrosion, sections were taken from service exposed 7178-T6 upper wing skins from retired Boeing 707 aircraft [3]. As outlined in Chapter 4, these sections were cold mounted and progressively polished to determine the damage state. An image of this section along with the NDI and polishing results are shown in Figure 6-1. It is interesting to note how the damage morphology substantially changed over a small distance, 1.067 mm (0.042 inches), from very little intergranular corrosion to considerable amounts of exfoliation. Although very little intergranular corrosion was present below the observed exfoliation, as can be seen from the arrows in Figure 6-1, the intergranular corrosion that was present was located very close to the maximum exfoliation depth. This suggests that if this area of the wing skin was repaired the intergranular corrosion would probably also be removed.

Figure 6-1: Results from the Progressive Polishing Carried Out on Specimen 362-B-S4-1 that Contained Visible Exfoliation (arrows indicate the location of the deepest intergranular attack).

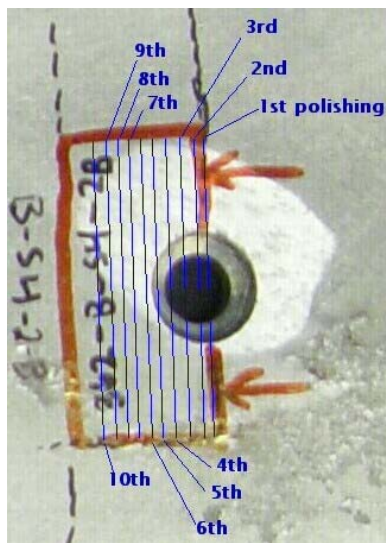
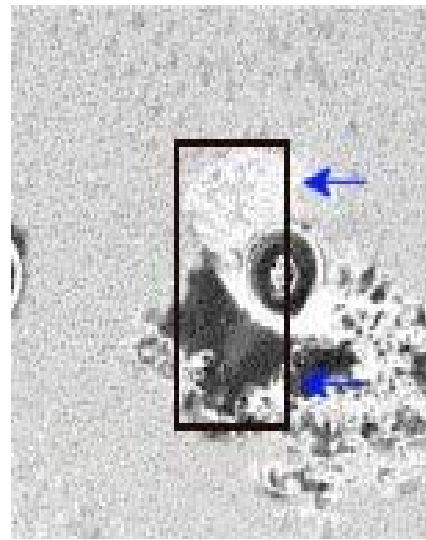
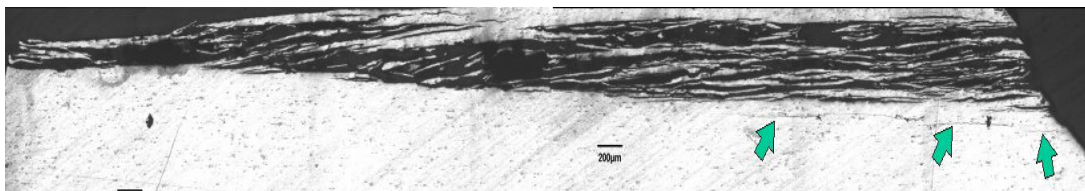
Another section that was taken from an upper wing skin contained both visible exfoliation and a repaired (ground-out) area. An image of this section along with the NDI and polishing results are shown in Figure 6-2. Although visible exfoliation was clearly present outside of the repaired area, no damage was detected within the area. It is interesting to note that as the polishing progressed the severity of the exfoliation decreased to intergranular corrosion, which extended into the repaired area. Whether the intergranular corrosion at this depth was present before the repair process was carried out could not be determined.

Figure 6-2: Results from the Progressive Polishing Carried Out on Specimen 362-B-S4-2 that Contained both Visible Exfoliation and a Repaired (Ground-Out) Area (arrows indicate the location of the deepest intergranular attack).

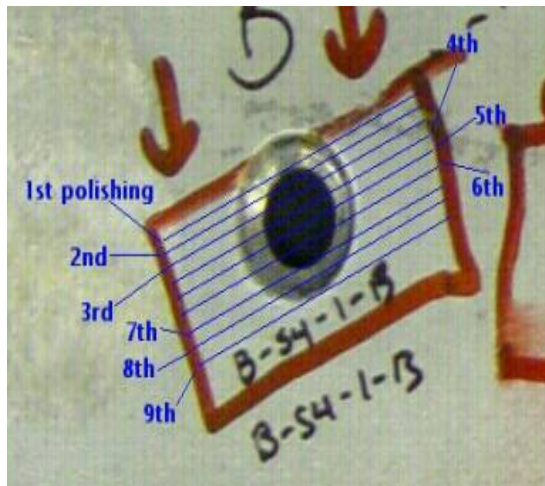
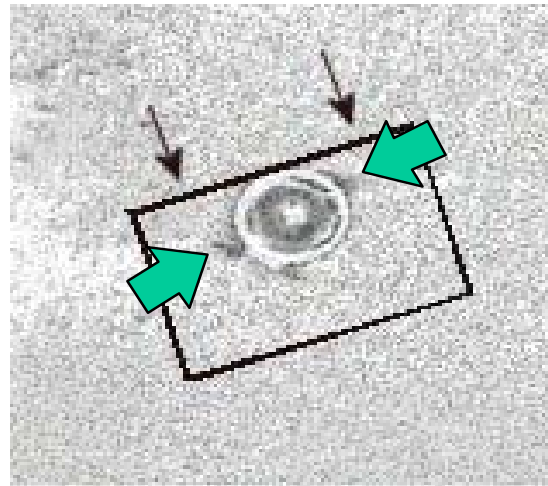
A section was taken from a 7178-T6 upper wing skin that did not contain any visible exfoliation, cold mounted and progressively polished, the results of which are shown in Figure 6-3. As can be seen from this figure, intergranular corrosion was present in the fastener area, which was detected by the ultrasonic inspection technique. This result demonstrated the sensitivity of the ultrasonic techniques to detect small levels of intergranular corrosion. It should also be mentioned that if a repair procedure were to be carried out in this area it is highly unlikely that all the intergranular corrosion would be removed, which is a requirement.

Figure 6-3: Results from the Progressive Polishing Carried Out on Section B Taken from Specimen 362-B-S4-1 that did Not Contain any Visible Exfoliation (arrows in (c) indicate the location of the deepest intergranular attack).

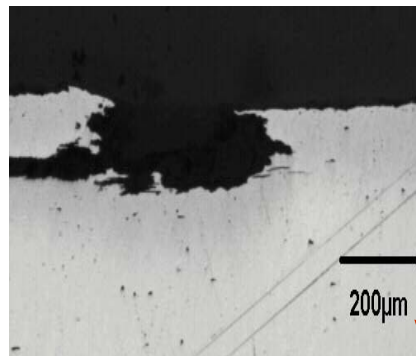
(a) Photograph of section SC3-1A.

Another study was carried out on exfoliated integrally stiffener extruded 7075-T6511 upper wing skins (that is fasteners were not present) [3]. Wing skins that were accidentally subjected to an age degradation process while in storage were used in this study. However it was determined that the damage sustained from this process was representative of the damage that occurred in service. Sections were taken from exfoliated areas; cold mounted and progressively polished using standard metallurgical techniques to determine the origin of the exfoliation as well as to characterize the damage present. Some of the results are shown in Figure 6-4 and Figure 6-5. From this characterization study it was found that the intergranular corrosion, which developed into exfoliation, originated at a modified discontinuity state (corrosion pit) that evolved from the age degradation process.

(b) Photomicrograph showing exfoliation present in section. Note corrosion pit (square) that was present, which may have started the intergranular corrosion.

Figure 6-4: Exfoliation Present Along S-T Direction 7075-T6 Upper Wing Skin.

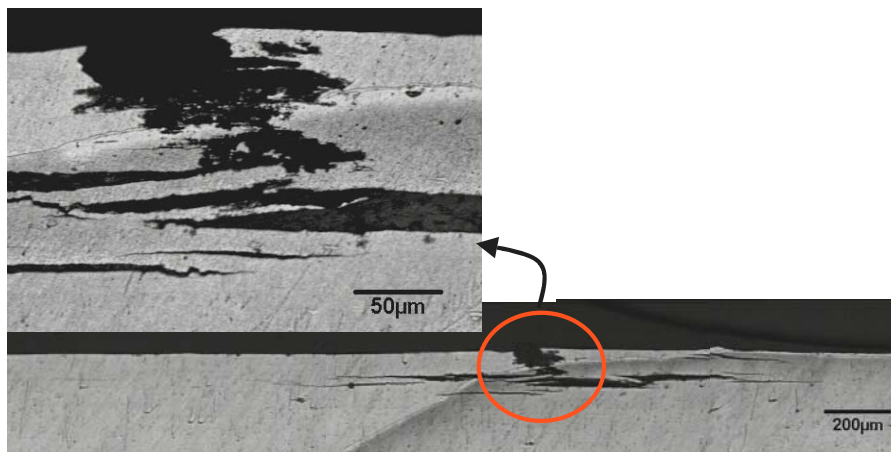
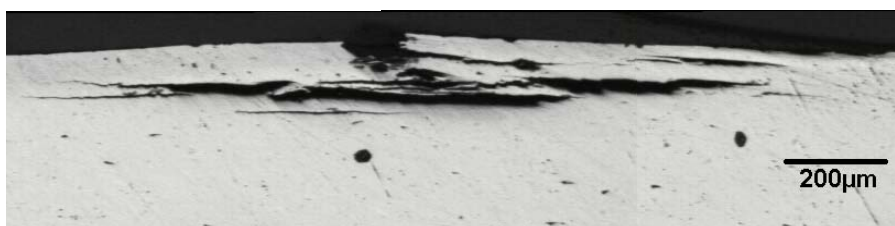
(a) Photograph of section SC5-3E.

(b) Photomicrograph of exfoliation present in section after first polish. Note presence of corrosion pit (circle).

(c) Photomicrograph of exfoliation present after second polish in same area as (b).

Figure 6-5: Exfoliation Present Along S-T Direction of Section Taken from 7075-T6 Upper Wing Skin.

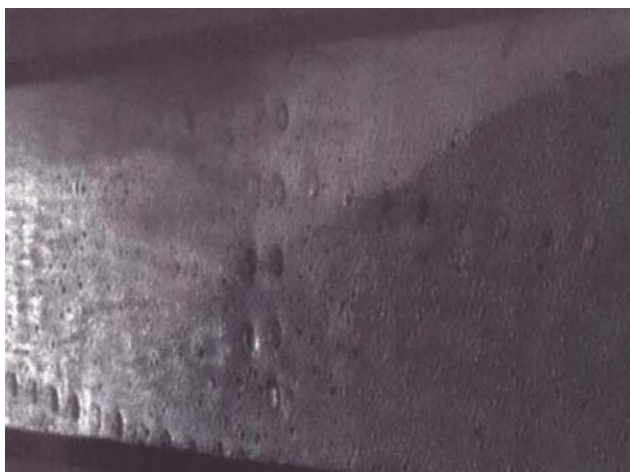
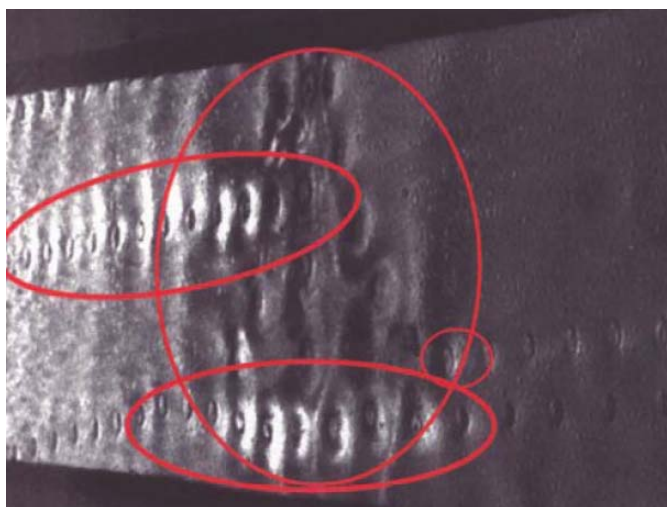
(a) No corrosion indications.

(b) Corrosion is present within the joint which is indicated by a bright to dark change in an area of the grayscale image.

Figure 7-2: Enhanced Visual Inspection Results (D-Sight™) of Fuselage Lap Joints.

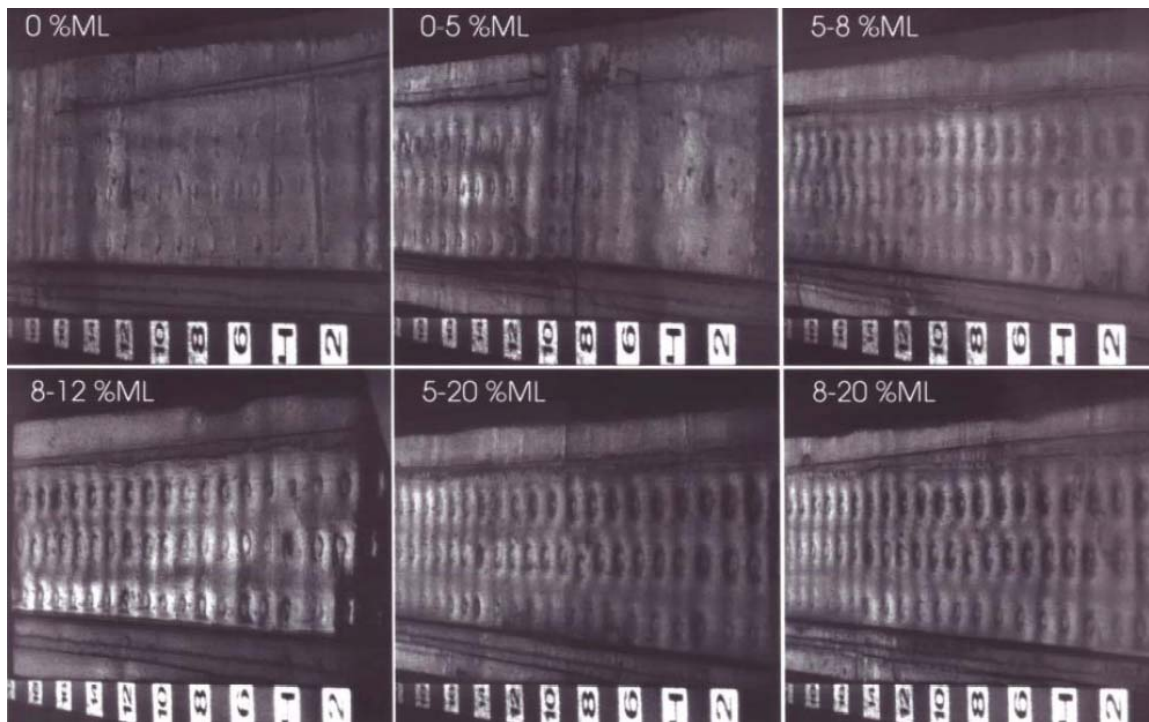
Figure 7-3: Various D-Sight™ Images Showing Degree of Pillowing for Different Level of Material Thickness Loss (ML).

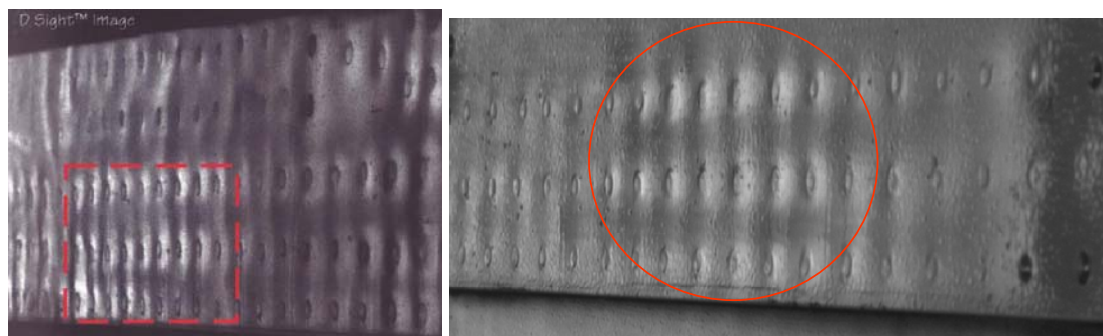
Figure 7-4: D-Sight™ Images Showing Pillowing Caused by Corrosion Products.

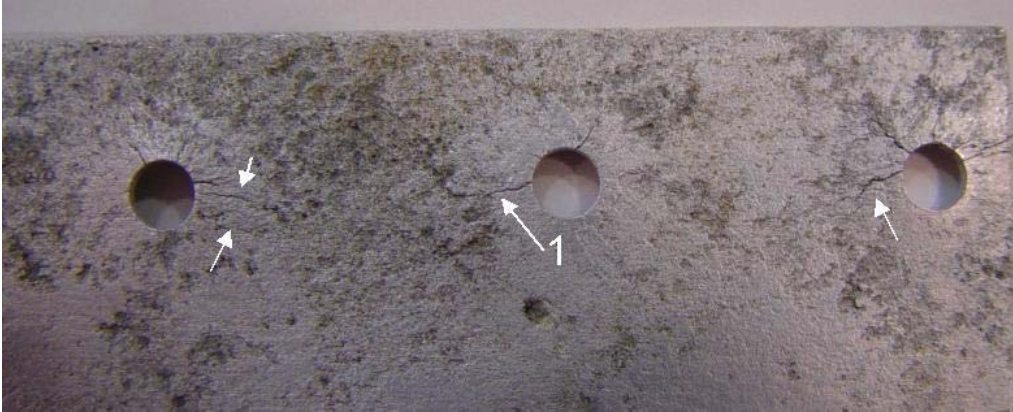
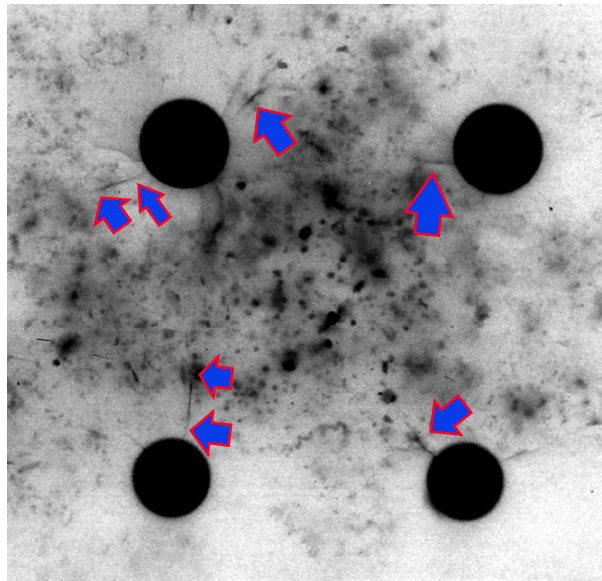
- Pillowing cracks tended to occur in groups (i.e., “star-shape” pattern cracks at more than one rivet hole), which did not normally penetrate through the thickness. The cracks always occurred on the side of the hole that was affected by the increased stress due to the pillowing and tended to propagate into the pillowed region Figure 7-6.
- The crack faces that were pried open contained corrosion products and showed extensive intergranular fracture with numerous secondary cracking, Figure 7-7.
- A number of the cracks had multiple nucleation sites. Although these sites could not be determined, they were evidently based on the different crack planes present, Figure 7-8.

(a) Optical image of cracks in Boeing 707 longitudinal lap joints.

(b) X-ray micrograph showing cracks in L1011 lap joint.

Figure 7-6: Various Images Showing the Typical Star-Shape Pattern Associated with Pillowing Cracks.

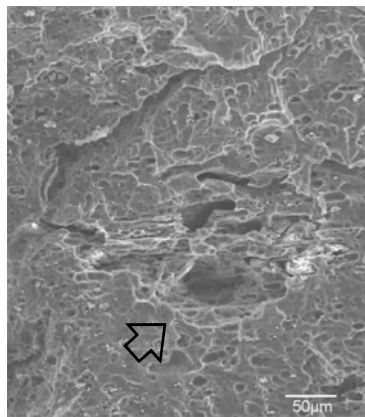
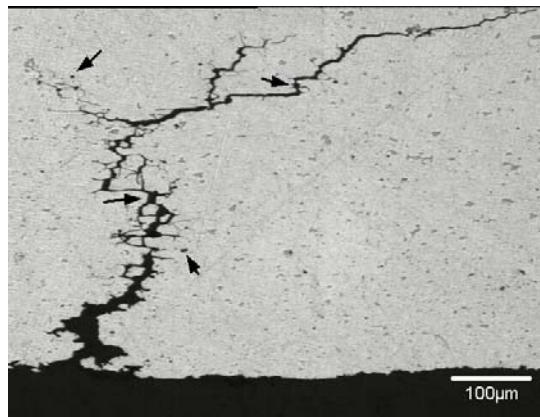
(a) Scanning electron micrograph of crack face.

(b) Optical micrograph obtained from progressive polishing.

Figure 7-7: Micrographs Showing the Intergranular Cracking with Numerous Secondary Cracks.

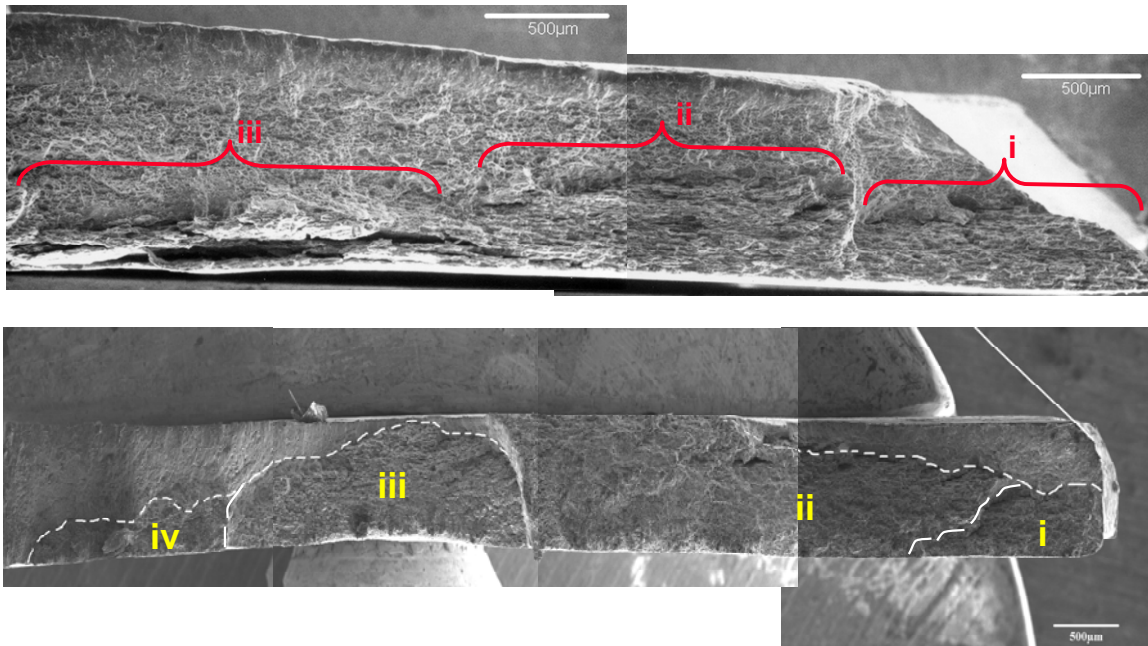
Figure 7-8: Micrographs Showing Multiple Crack Nucleation Sites.

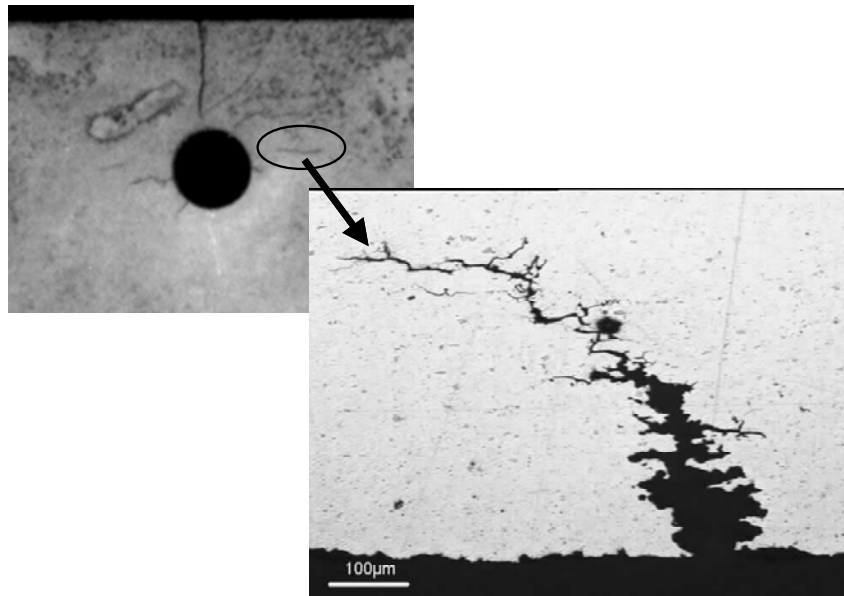
- The crack growth through the thickness was not perpendicular to the faying and outer skin surfaces but occurred at an angle, Figure 7-9.
- Some of the fracture surfaces contained fatigue striations near the crack edge where the corrosion was light, Figure 7-10 and suggests that once these cracks form, they may continue to grow under fatigue loading.

Figure 7-9: Optical Image of Pillowing Crack Showing Angled Crack Growth.
(Note that the crack occurred away from the edge of the hole but is still within the highly stressed area caused by the corrosion pillowing.)

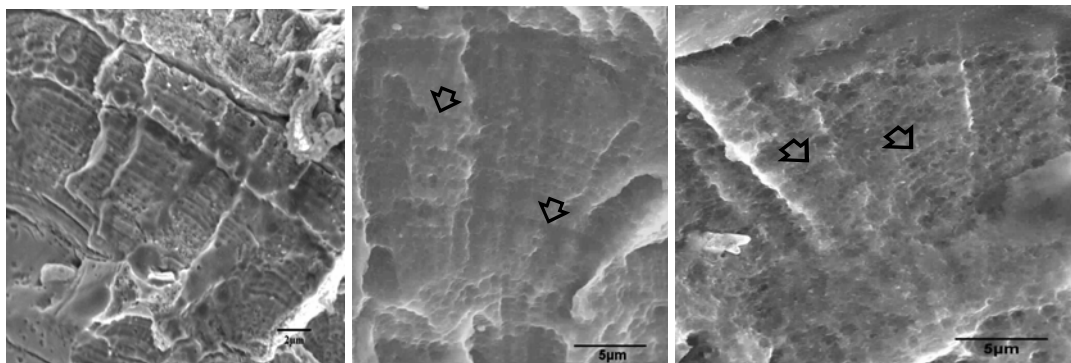
Figure 7-10: Scanning Electron Micrographs Showing Fatigue Striations that were Found on the Fracture Surfaces on Some Pillowing Cracks.

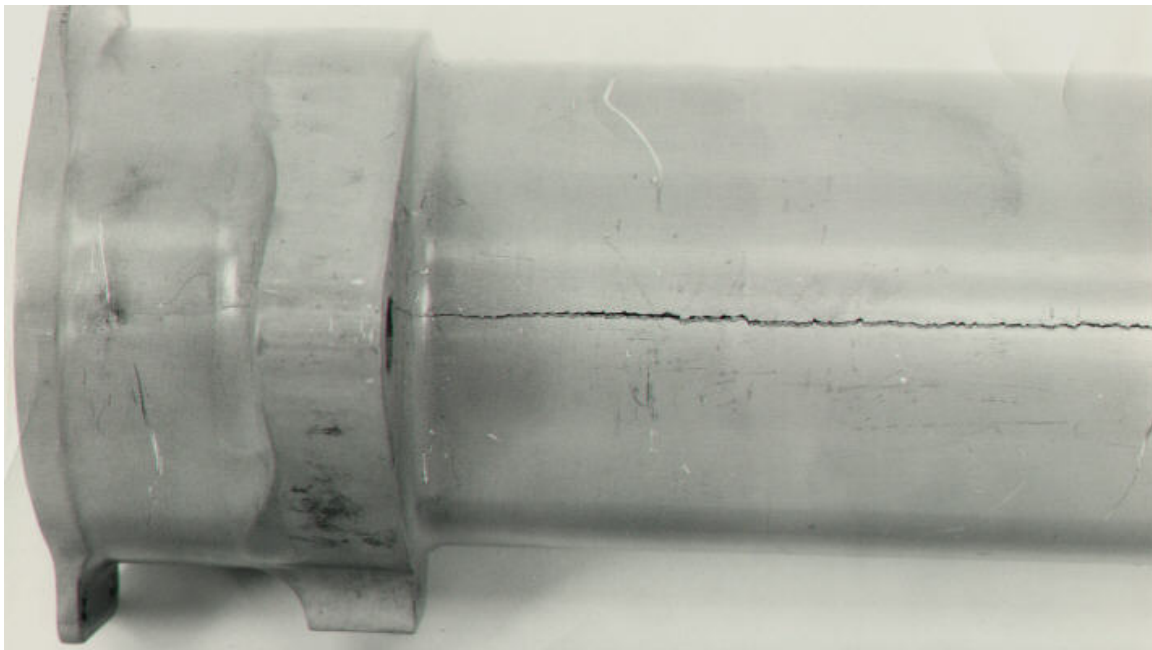
A landing gear shock-strut cylinder was subjected to fatigue tests with an applied internal pressure of 41.4 MPa (6 Ksi) and an R-value of zero in the laboratory air environment. The cylinder (wall thickness 't' = 5.59 mm or 0.22 in. and inner radius = 44.5 mm or 1.75 in.) was made from a die forging of 7075-T73 aluminum alloy material. The K_{IC} value for 7075-T73 is about $32.6 \text{ MPa}\sqrt{\text{m}}$. After 30,000 cycles, fracture occurred along the parting plane as shown in Figure 13-3. Subsequent failure analysis revealed numerous pits on the internal surface of the cylinder. Figure 13-4 shows a transverse section through one of these pits. The depth of the pit was quantified at about 6 mils. or 0.15 mm. Also, as shown in Figure 13-5 the fracture surface revealed a semi-circular fatigue crack that originated from a pit on the internal surface of the cylinder. The crack depth (a) and crack width (2c) were found to be 4.32 mm (0.17 in.) and 9.65 mm (0.38 in.) respectively [52]. The nominal hoop stress at the fracture location was calculated at about 331.2 MPa (48 ksi). The calculated hoop stress was about 68% of the parent material ultimate strength and 80% of the nominal design stress (414 MPa or 60 ksi) for the component.

Figure 13-3: Fracture Along the Parting Plane of 7075-T73 Shock-Strut Cylinder.

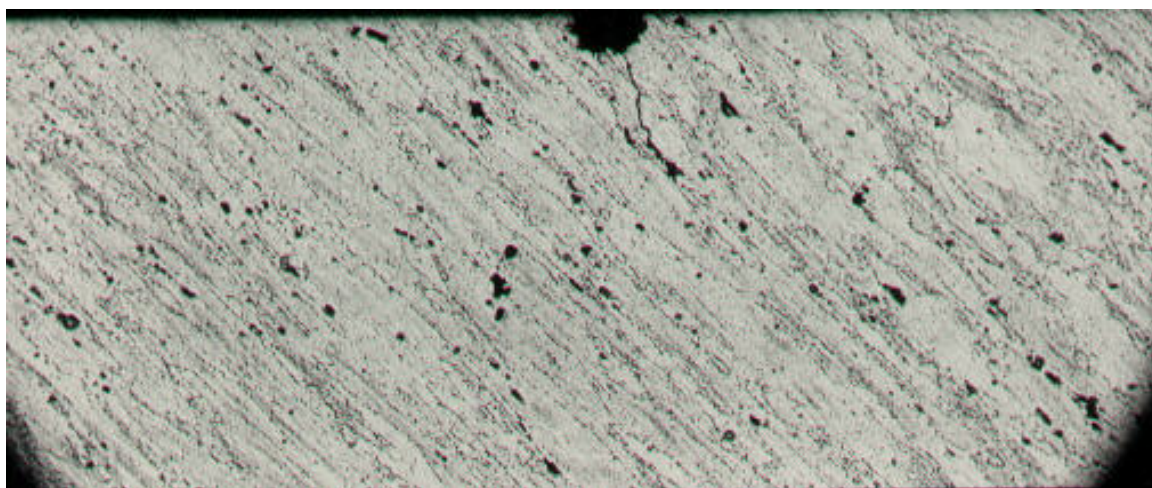
Figure 13-4: A Transverse Section of a Pit on the Inner Surface of the Shock-Strut Cylinder (Note a fatigue crack nucleated from the pit).

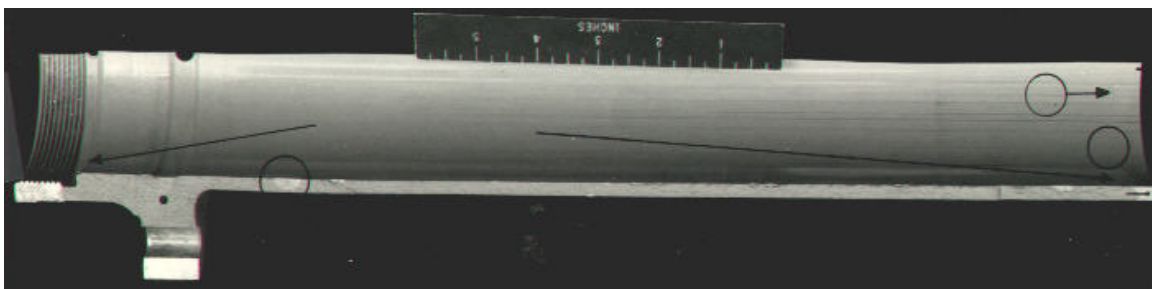
Figure 13-5: A Semi-Circular Crack Originated from a Pit that was Found on the Inner Surface of the Shock-Strut Cylinder (shown by an arrow pointing a circle).

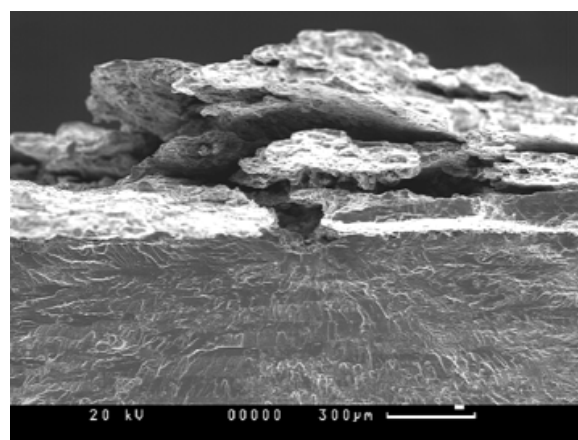
The pit-like intrusions were of particular interest because they, more than any other feature, supported the process zone model. Note the convincing image of the ‘process zone’ shown in Figure 15-2 [19]. This specimen, exposed for 48 hours, shows a classic pit-like fatigue crack origin along with the general thinning associated with advanced exfoliation.

Figure 15-2 : Pitting and Exfoliation at Crack Nucleation Site in Specimen Exposed 48 Hours to EXCO (after [20]).

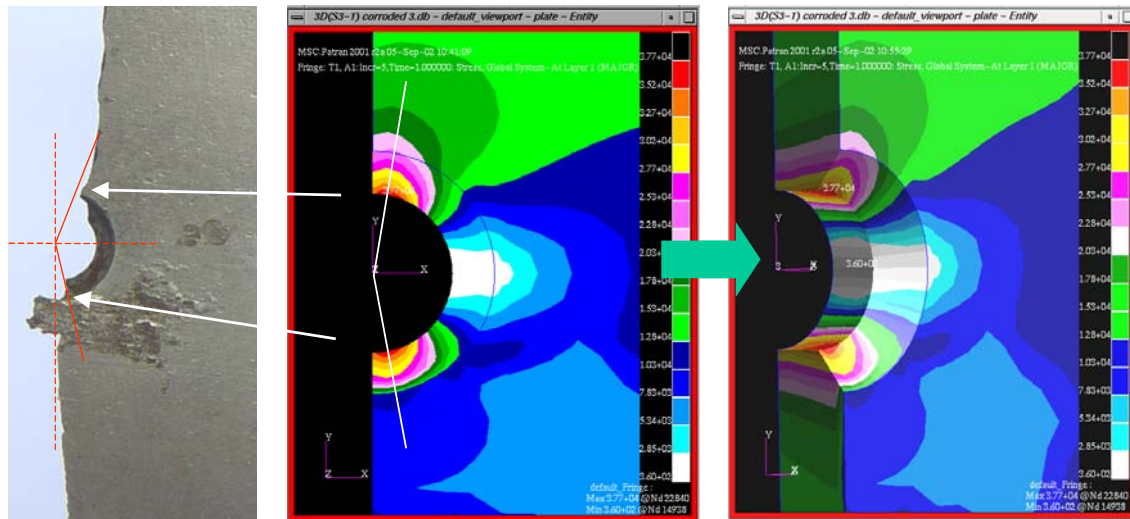
Figure 15-8. The crack nucleation sites are located near the 1 o'clock and 5 o'clock positions. The FE analyses were carried out under both tension and compression loading in order to obtain the local stress results for fatigue analysis.

Figure 15-8: Crack Nucleation Site and 3D FE Analysis Results.

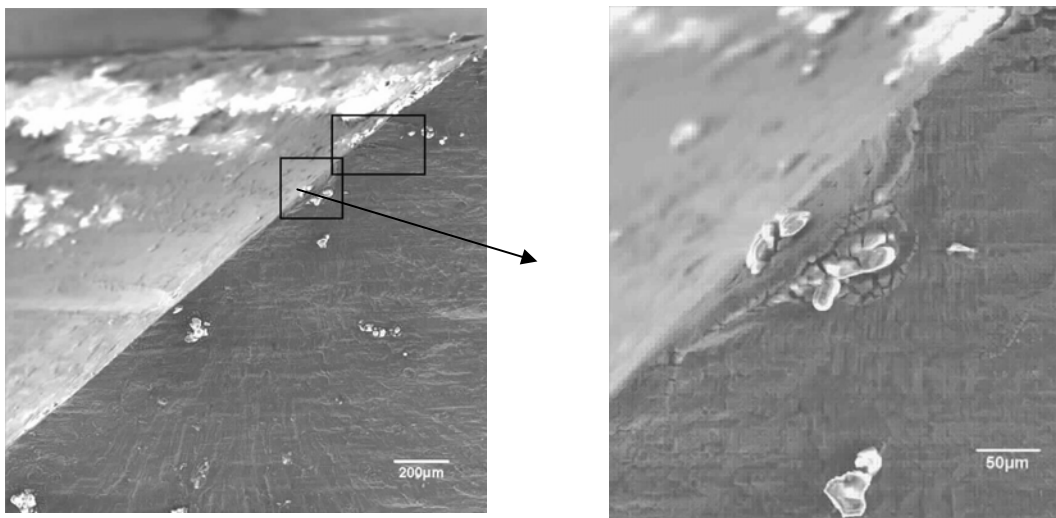
Fatigue tests were carried out on naturally exfoliated 7178-T6 coupons, using a constant amplitude loading ($R = -1.67$, $\sigma_{\max} = 12$ ksi). The fractography found that a primary crack formed from a corrosion pit-like discontinuity on the countersunk surface of one coupon. This coupon was cut from a B707 wing panel, with 5.4% exfoliation (i.e., max. exfoliation depth/nominal thickness) at the fastener hole, Figure 15-10.

Figure 15-10: Crack Nucleation Site at a Colony of Corrosion Pits on Countersunk Surface.

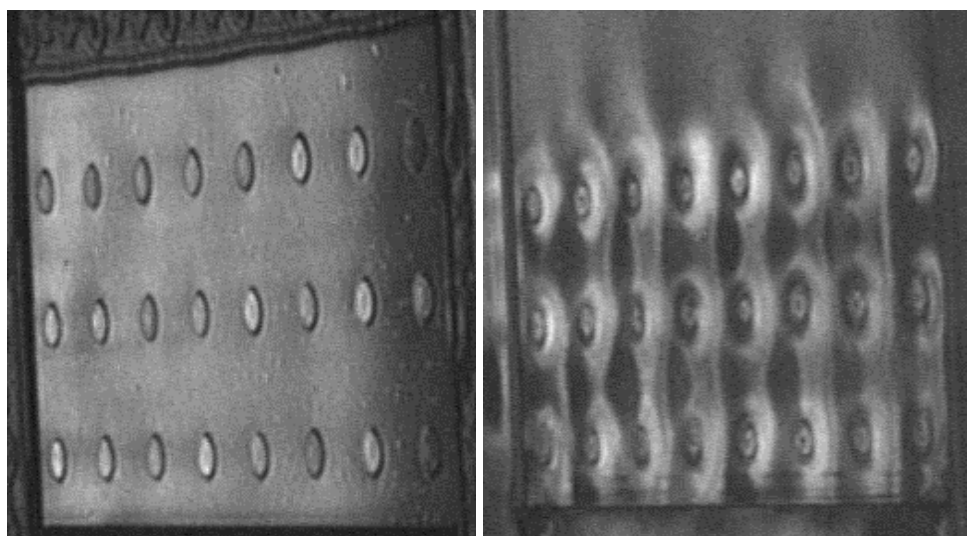
The corrosion build-up inside the splice caused pillowing distortion. This distortion can be seen clearly in comparing the images of corroded and non-corroded specimens in Figure 16-2, which were obtained using the D Sight Aircraft Inspection System (DAIS). The distortion can significantly affect the stress distribution in a splice, and has been modeled in other work at the National Research Council (NRC) Canada [6]. Measurements of pillowing distortion were used to monitor the level of corrosion during the pre-corrosion process.

Figure 16-2: D Sight Aircraft Inspection System (DAIS) Images of a Lap Splice Specimen Before Corrosion (left) and After Corrosion (right).

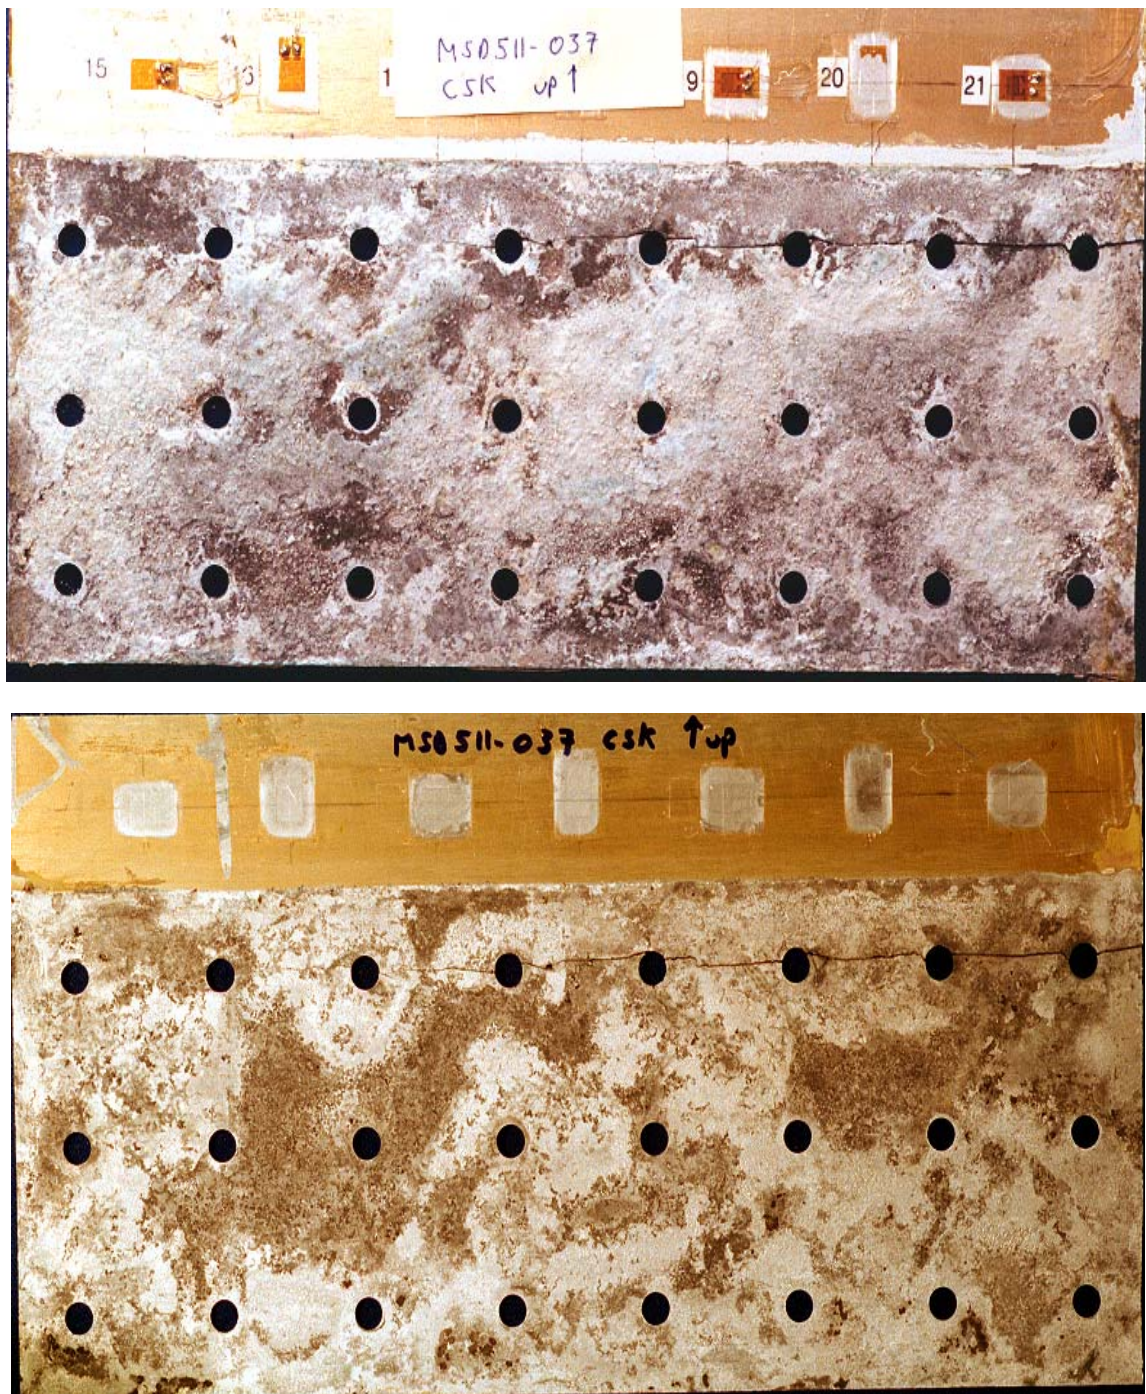
Figure 16-3: Faying Surface of the Countersunk Sheet of Specimen #037 Before and After the Removal of Corrosion Products.
